BROWNS FALLS DAM

INVENTORY № NY 762

**PHASE I INSPECTION REPORT
NATIONAL DAM SAFETY PROGRAM**

SEPTEMBER 1979

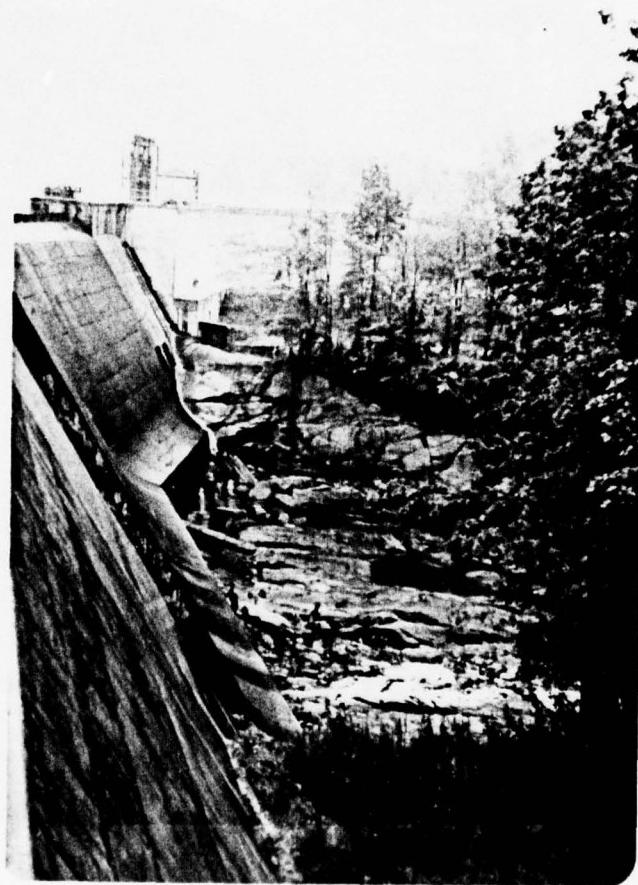
Overview of Brown's Fall Dam looking south across the downstream face of the dam.

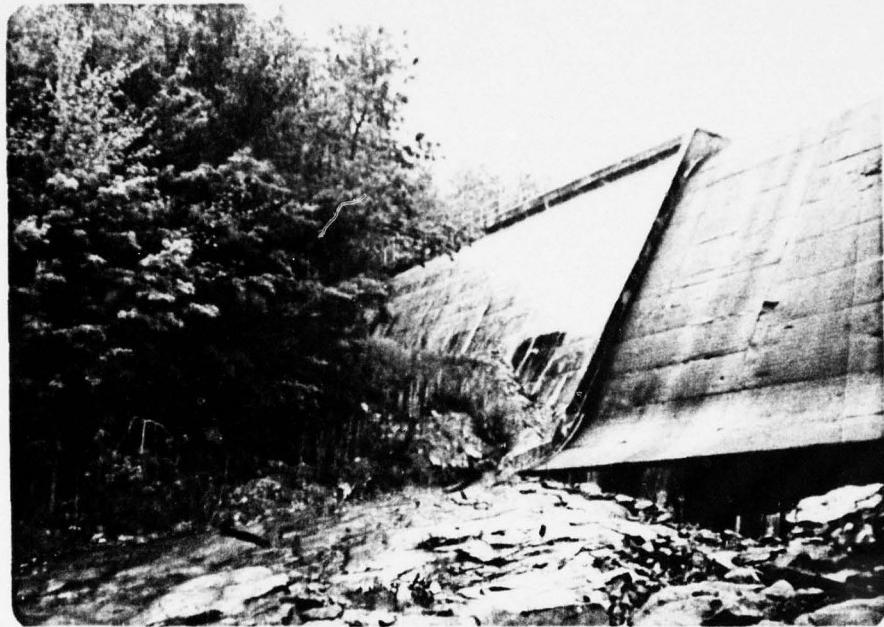
3. The north portion of the dam has a 12 inch concrete overlay on the downstream face. This recent overlay has limited seepage at the base and through the construction joints.

The dam's crest walkway and downstream faces have been rehabilitated/resurfaced at different times in the past, the most recent being the crest area of the dam's left section and the downstream face of the right northerly non-overflow section. The concrete exposed in these zones is generally in good condition. Concrete exposed in the spillway section is also generally in good condition, but some horizontal construction joints show some deterioration. The downstream face of the dam's southerly left section was resurfaced (shotcrete) a number of years past (on the order of twenty to thirty years) and this veneer is cracked and apparently separating from the main structural section (the material is buckled with a hollow sound when tapped) at a number of locations. The weather was rainy at the time of this inspection, masking signs of any through-the-dam seepage. It does appear that minor seepage occurs through this southerly section of dam at some locations. There also exists signs of seepage through the lower segment of the dam's northerly non-overflow section.

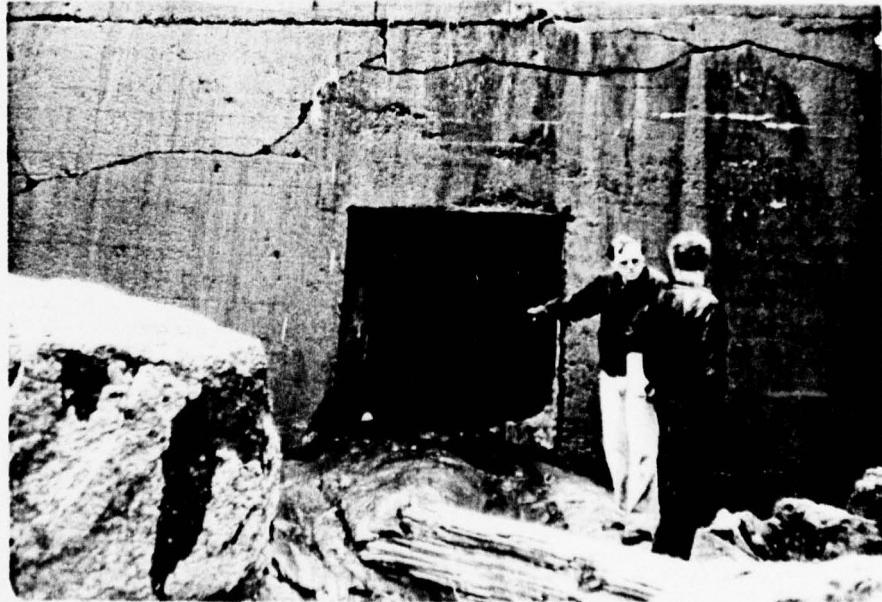
6. Close-up of plugged low level outlet. Notice surface cracks in spillway section.

5-1/2 foot sluice gate is located within the spillway section to provide low level outlet. However, this outlet is plugged at the inlet of the opening so that the impoundment cannot be fully drawn down. Provisions have been made in the forebay of the powerhouse outlet to accept a second pipeline in the future. The outlet from the forebay to this future pipeline is presently plugged concrete. The receiving stream is composed entirely of bedrock and no signs of recent erosion were noted.

5. Provide a low level drain for the impoundment by rehabilitating the existing drain opening removing the blockage, and installing a control gate.
6. The condition of the concrete beneath the deteriorated shotcrete surface on the south non-overflow section should be investigated. Remedial work should be undertaken to correct any concealed defects in the original concrete structure.

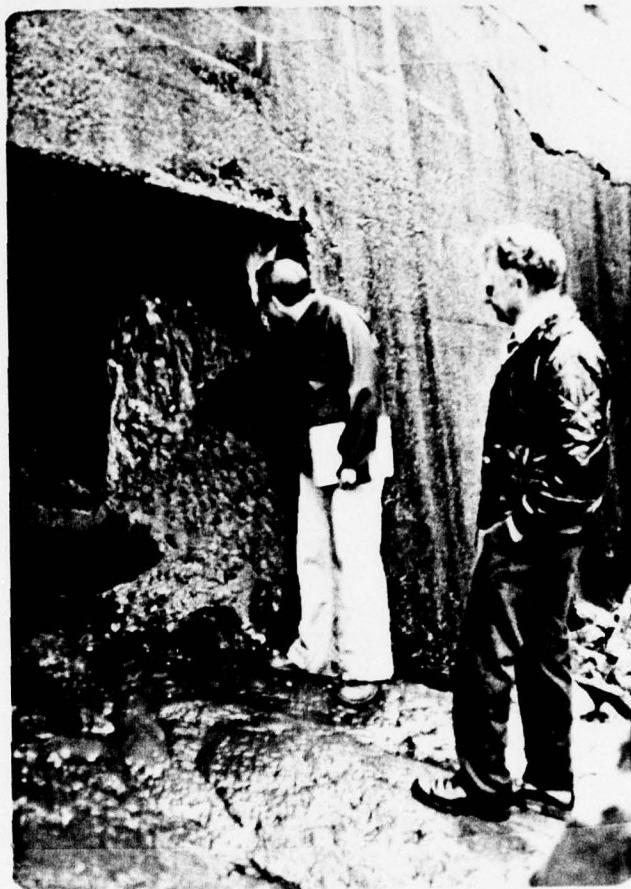
7. Detail of dam level outlet wall showing deteriorated concrete.

Concrete deterioration is occurring in the section of tunnel which comprises the spillway overflow outletting at the spillway section's downstream toe.

The condition of the shotcrete surface on the downstream face of the dam's left section should be investigated by coring or similar resulting procedure to determine the need for repair/replacement. Plans for concrete repair should extend to the spillway tunnel.
